DSTO-TR-0366

Evaluation of Innovative NDI
Methods for Detection of
Widespread Fatigue Damage

P. Khan Sharp,
D.E. Rowlands and G. Clark

**Airframes and Engines Division
Aeronautical and Maritime Research Laboratory**

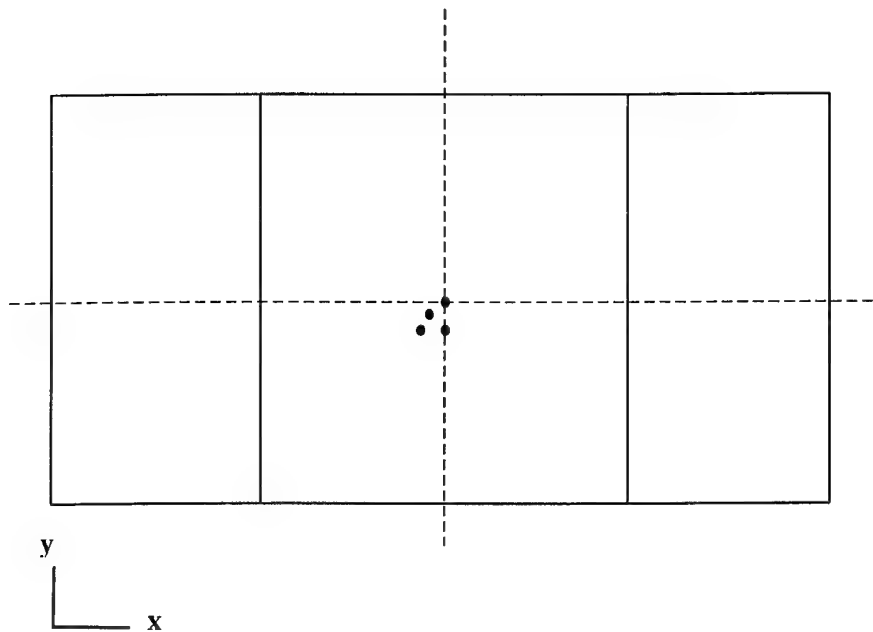
The only indications of cracking after program 23+13493tp, were sites (i) and (ii), the other possible having been confirmed as false positive indications. The lack of apparent development of indications (i) and (ii) between programs 14 and 23+, and the lack of development of any other indications in this period indicates non crack-like behaviour. However, as indicated earlier, it was necessary to continue the test until cracks grew to visible length in order to confirm/reject indications confidently.

Figure 15: Location of possible cracks detected with laser ultrasonics. These possible crack locations could not be confirmed by any other method.

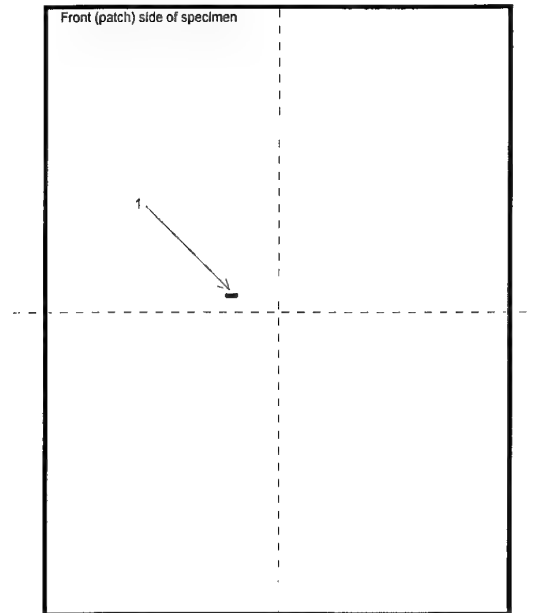
The crack was detected under the patch, though the lag in the system made it difficult to locate the crack precisely. The patch was not removed to confirm the presence of a crack by conventional NDI techniques.

Figure 16: The suspected location of the crack detected, this location was not precise due to the lag in the instrument system.

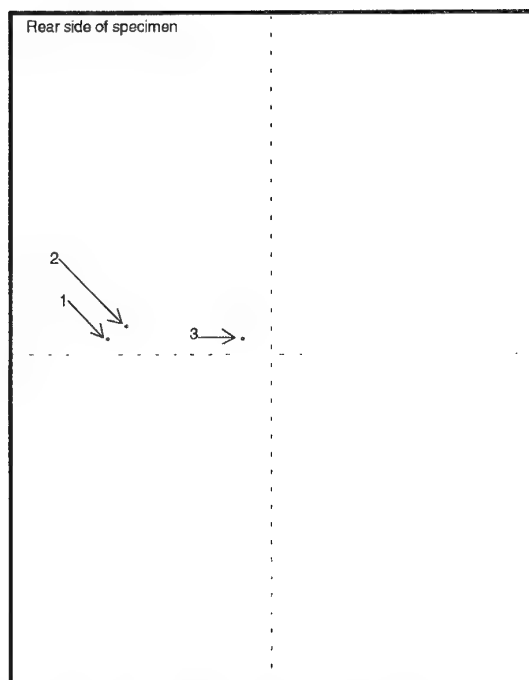
Figure 17: A schematic of the location of the three cracks detected.

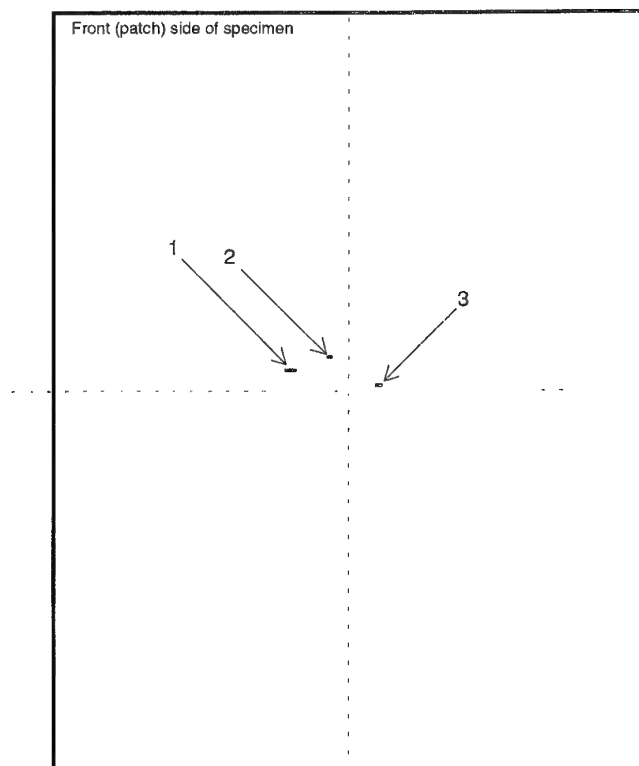
Three possible microcracks were located approximately 56 mm, 62 mm and 75 mm from the left hand edge of the specimen. It was not possible to locate the cracks vertically under the patch.

Figure 19: A schematic of the location of the three cracks detected by the structural integrity monitor (Model 2).

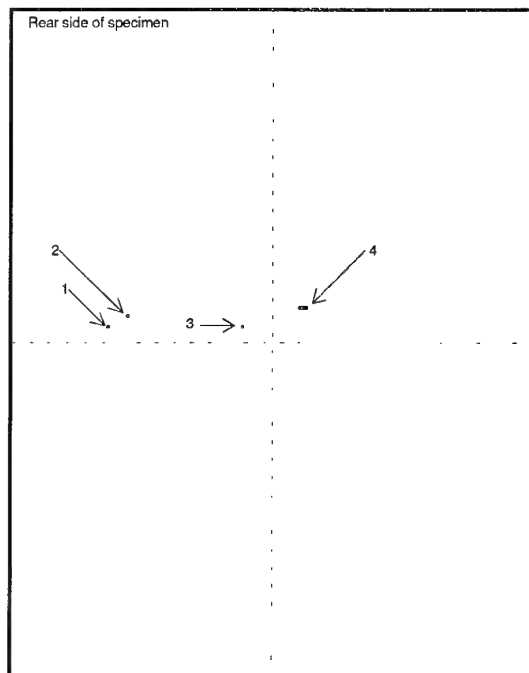
Figure 20: A schematic of the locations of the four cracks now found. Three cracks were found after program 26 (No's 1,2,3) and a new large crack was found at location No. 4.

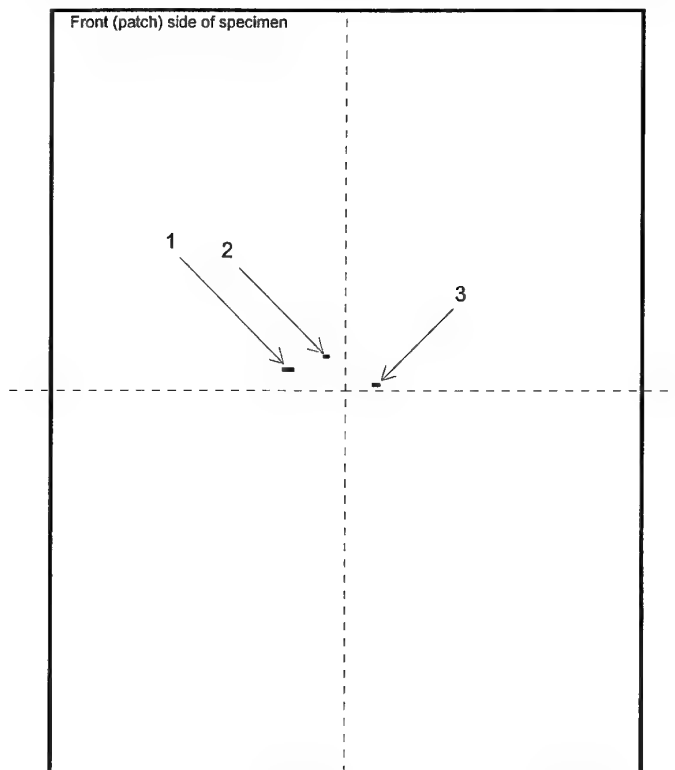
The crack was located approximately 58 mm from the left hand edge. Though there were still indications at approximately 65 mm and 70 mm the signal was being dominated by the crack located 58 mm from the edge. This indicates that there was one large crack at 58 mm and two small cracks at 65 mm and 70 mm. The fact that the zero load differential reading was slowly creeping up also indicated that a crack was present.

Figure 23: A schematic of the location of the three cracks detected by the structural integrity monitor (Model 2). Crack No.1 was large and starting to swamp the signal from cracks No. 2 and No. 3.

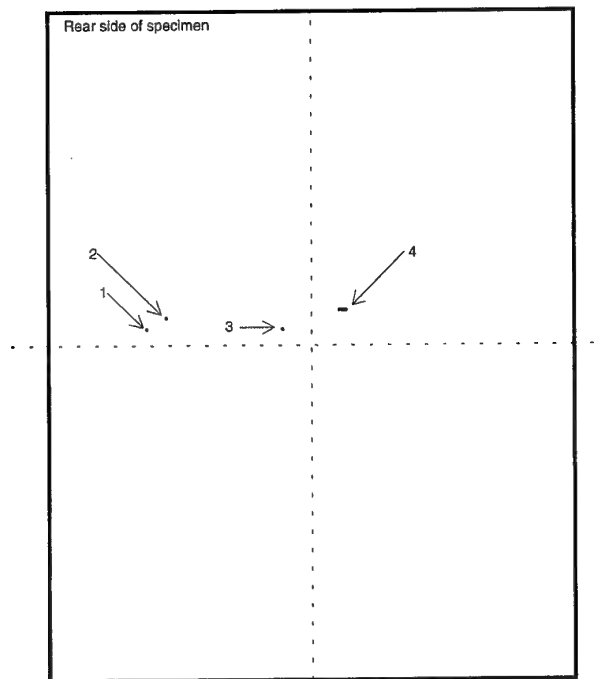
Figure 24: A schematic of the location of the four cracks detected with holographic interferometry.

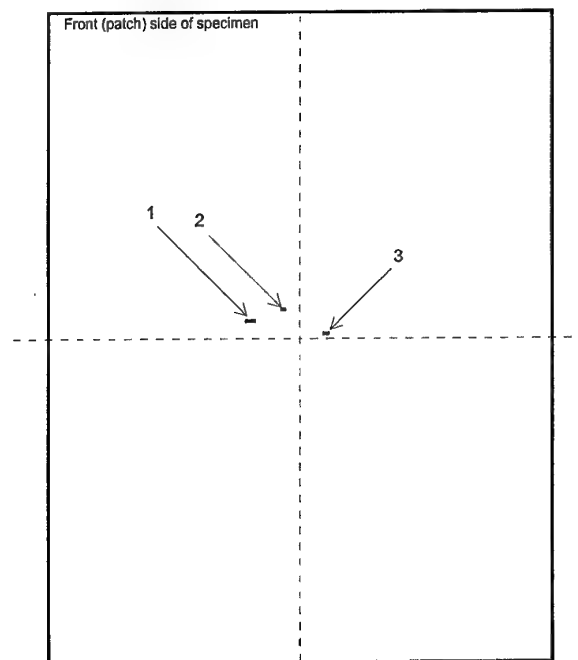
Three cracks had been identified, though the signal from crack No.1 was swamping other indications that may have helped to locate other cracks.

Figure 27: A schematic of the location of the three cracks detected by the structural integrity monitor (Model 2).

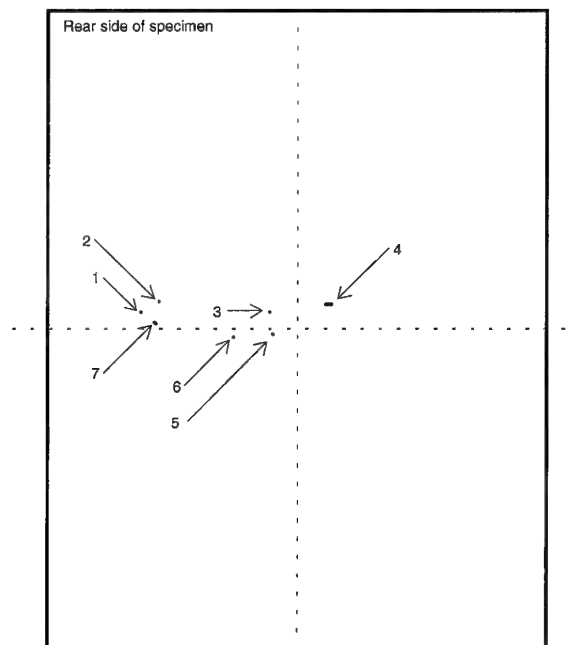
Figure 28 is a schematic of the crack locations observed after program 29. Plate No. 24 clearly shows a number of cracks present, Figure 29.

Figure 28: More cracks were located as shown in this schematic. Note that crack No.4 does not appear on this image.

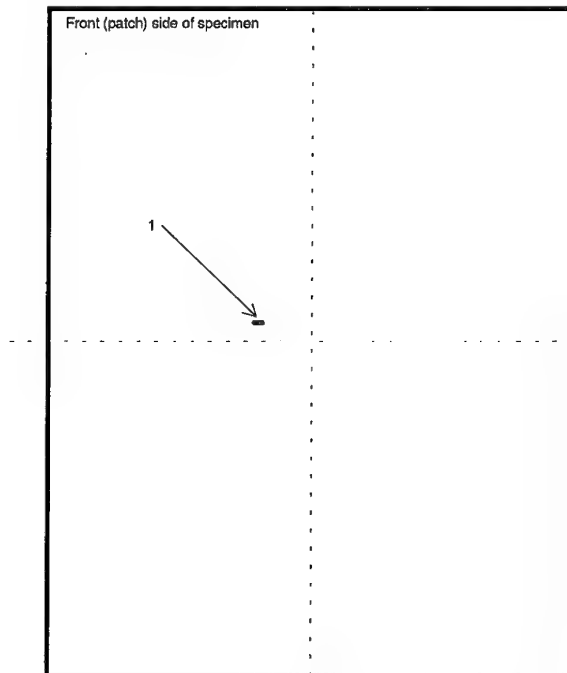
The structural integrity monitor patch was removed from the front of the specimen and a hologram taken of the specimen front. Figure 30 shows the location of the crack found by holographic interferometry, Figure 31. There are indications of three other cracks. The located crack is the main crack found by the structural integrity monitor.

Figure 30: A schematic of the large crack located on the structural integrity monitor side after the patch was removed. The location agrees with the large crack found by the structural integrity monitor.

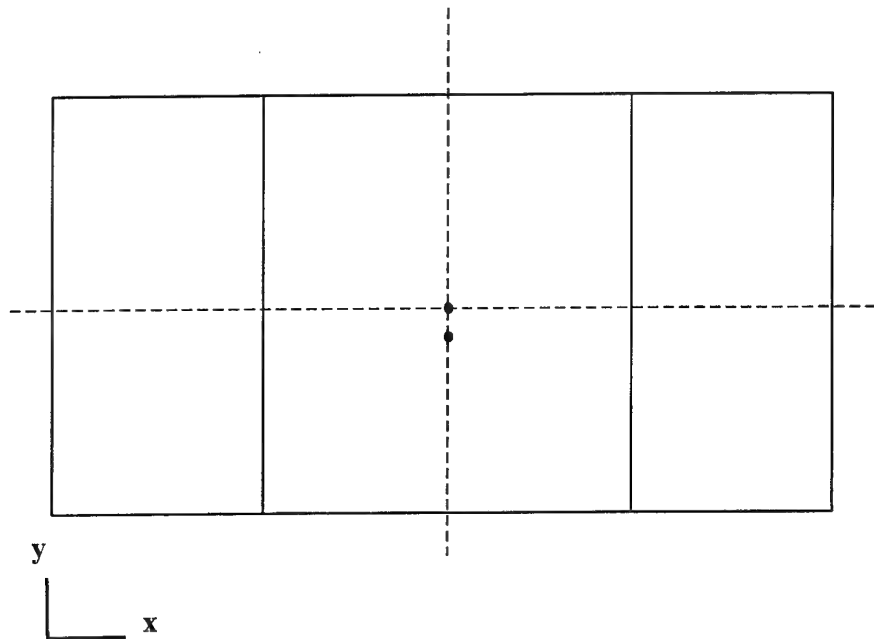
This inspection again showed indications of cracks at (i) and (ii). A final series of consistency checks were made on the data at this stage, including detailed comparison of the transmission results for various "y" values.

Figure 32: A schematic of the location of the two crack indications found with laser ultrasonics

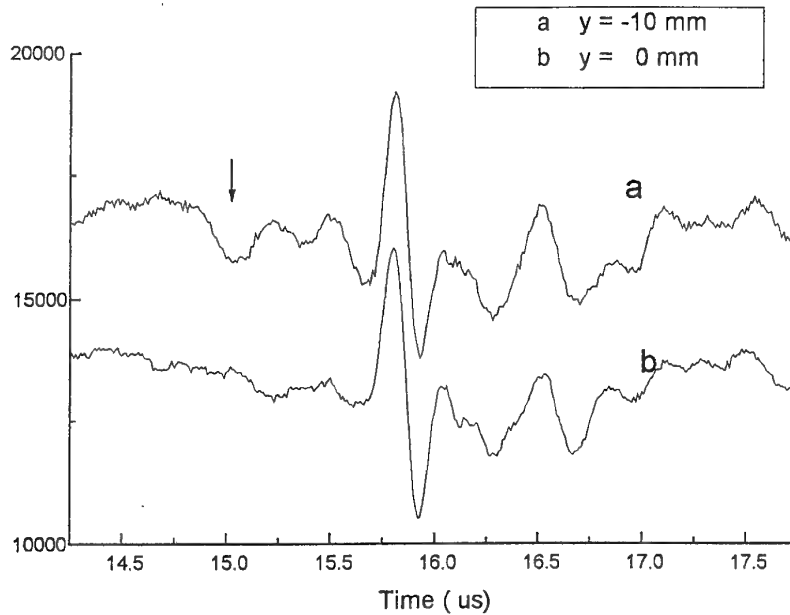
Figure 33: A typical waveform transmission from the test [3]. The difference between the two waveforms is the arrowed peak, which is attributed to a crack.

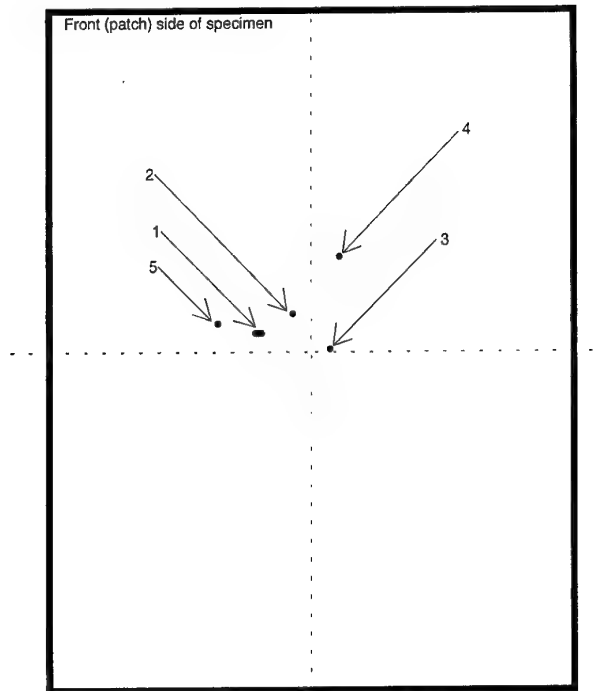
Figure 35: The five cracks located by fluorescent dye penetrant on the front of the specimen (structural integrity monitor side). The visual intensities are a good indication of the crack size and are as follows; crack 1-very bright, crack 2-bright, crack 3-bright, crack 4-weak and crack 5-weak

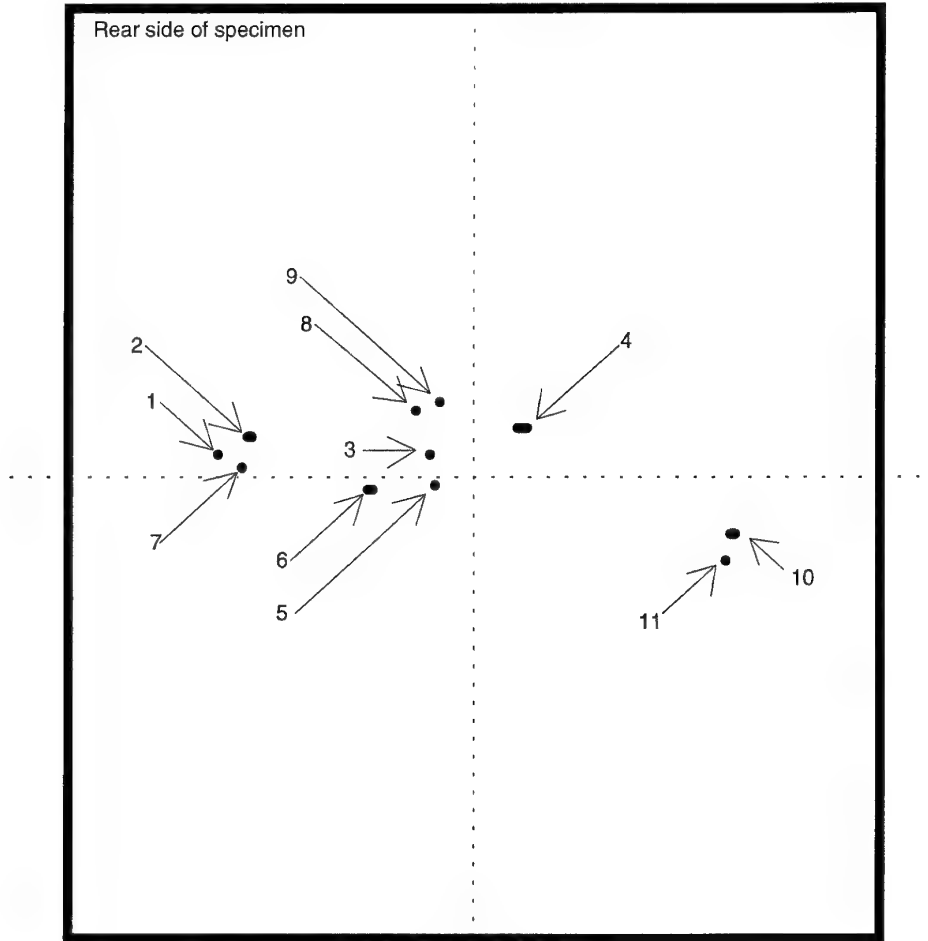
Figure 36: The eleven cracks found by fluorescent dye penetrant on the back of the specimen (holographic interferometry side). The visual intensities are a good indication of the crack size and are as follows; crack 4-very bright, cracks 2, 6, 10-bright and cracks 1,3,5,7,8,9,11-weak.

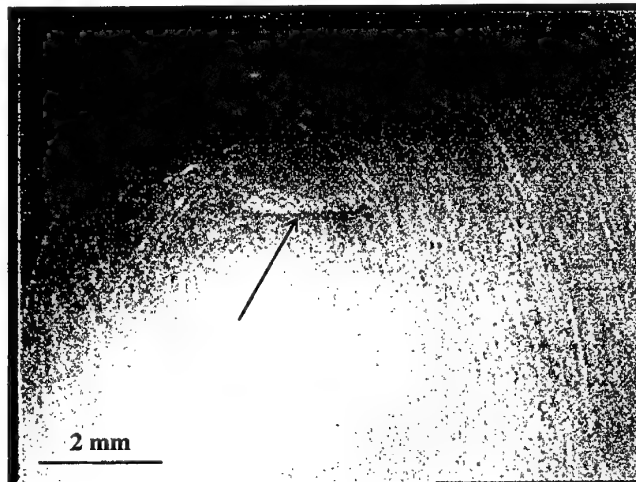
Figure 37: Images of the large crack on the "Davey System" side, observed with the microwatcher (crack No. F1).

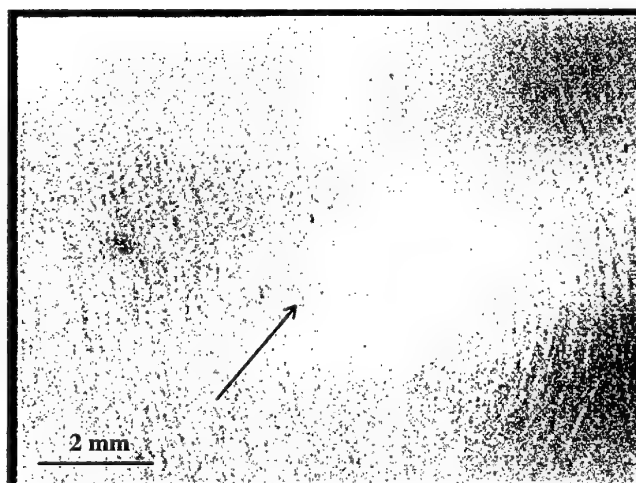
Figure 38: Images of the large crack on the holographic interferometry side, observed with the microwatcher (crack No. R4).

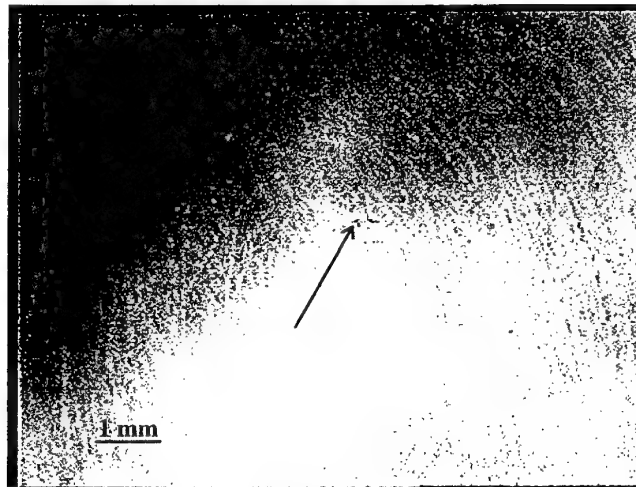
Figure 39: Images of the second crack on the holographic interferometry side, observed with the microwatcher (crack No. R6).

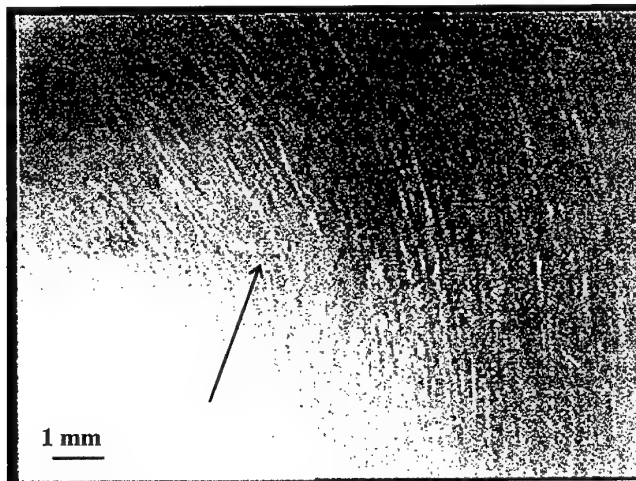
Figure 40: Images of the second crack on the "Davey System" side, observed with the microwatcher (crack No. F2).

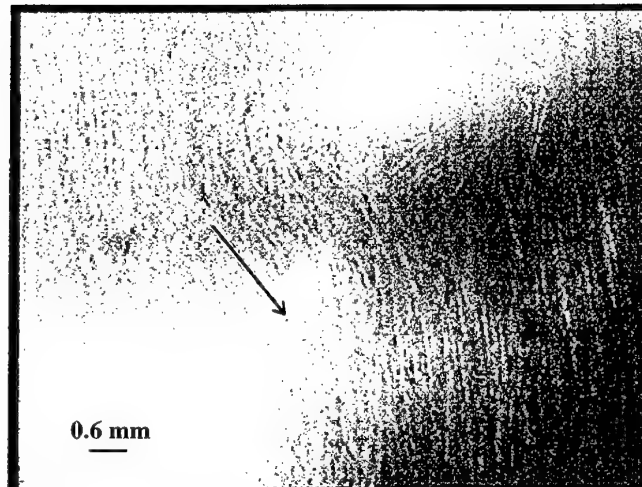
Figure 41: Images of the third crack on the Davey system side, observed with the microwatcher (crack No. F3).
